DAMAGE AND RESTORATION OF THE ELECTRIC FACILITIES IN THE GREAT HANSHIN-AWAJI EARTHQUAKE

Masaharu Kanayama

The Kansai Electric Power Co., Inc.

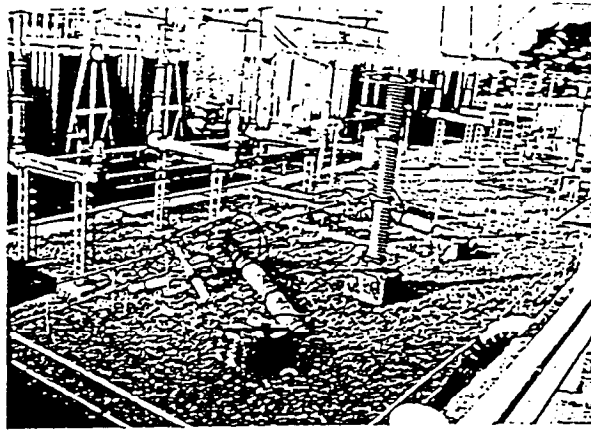
Damage was sustained by 181 facilities in 50 substations, while the destruction of major facilities caused outages at 65 facilities in 17 substations. These outages were attributable to the slippage of transformers caused by tensile fractures in anchor bolts that fixed transformers to their foundation, oil leakage caused by displacement of the bottom of bushings of old-model of oil circuit breakers slid on the gaskets, or destruction of insulators of disconnectors.

(a) Damaged Arresters and Disconnectors in a Substation.

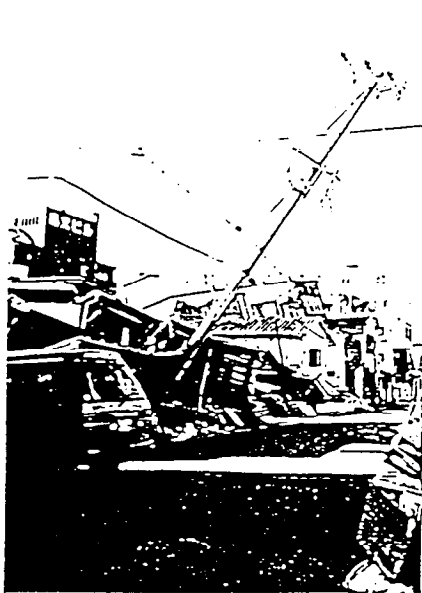
Damage to overhead distribution lines, which led to outages, included the breakage and collapse of 3,300 the distribution poles; the breakage and burning down of about 2,700 spans of electric cable; and breakage and burning down of about 1,200 bushings of transformers. Approximately 80% of the breakage and collapse of the distribution poles was secondary damage following the collapse of surrounding buildings. Most of the damage to cables was caused by the spread of fire and the breakage of the distribution poles.

(b) A leaned distribution pole due to the collapse of a building.

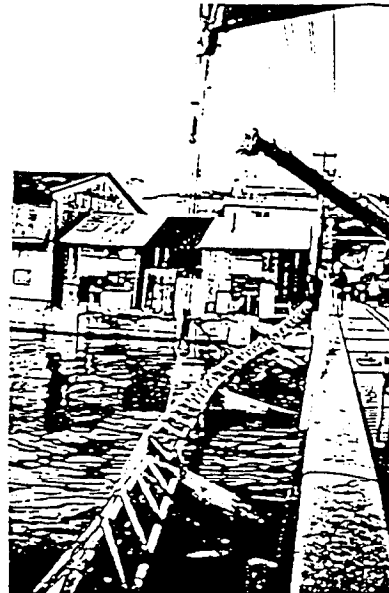
Damage leading to outages occurred in 3 lines and 20 phases, which featured a special conduit structure. This structure was so rigid that it could not cope with ground movements, and this caused cable damage.

(c) Destroyed bridges for underground wire.

The report on the investigation recommended that, with regard to underground lines, in respect of which no seismic design criteria are specified, the parameters applicable to designs using flexible joints and conduits should be established, with any necessary modifications and improvements, as seismic design criteria. With regard to other facilities, it evaluates that the current seismic design criteria, which were established based on lessons learned from previous earthquakes can suitably specify earthquake resistance, which each electricity facility should equip, and recommended that those facilities which were built on the basis of old criteria, and which can be expected to be the cause of serious supply outages, as well as of damage elsewhere, should be brought into conformity with current criteria.
